9-26-96 Bob Blaesing, IDEM  
Gary Development Company  
#1 -- View of GDC landfill, south  
face. Note rill erosion, lack of  
vegetative cover.

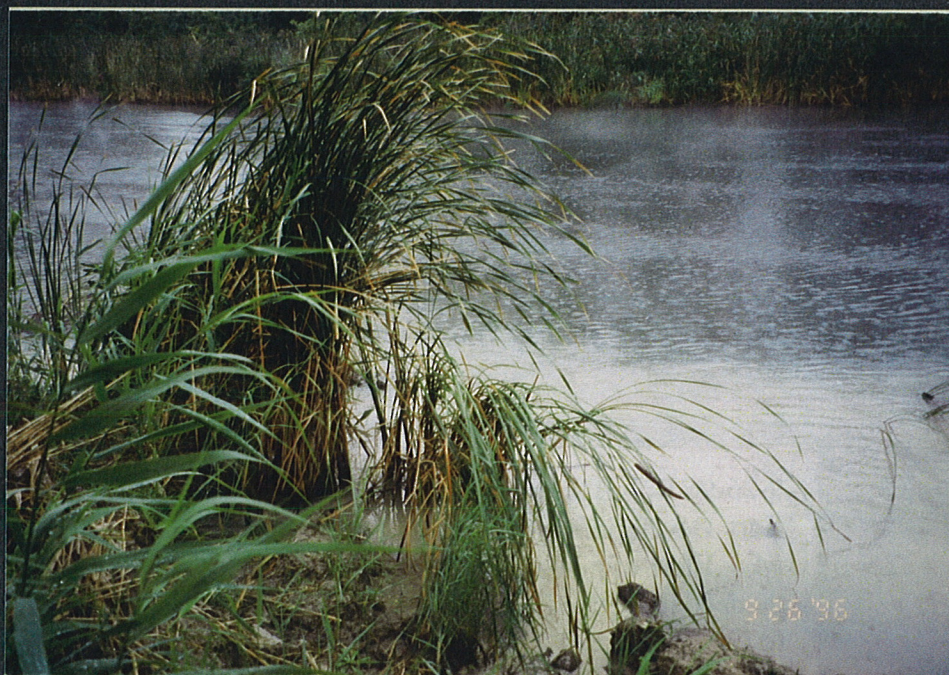
9-26-96 Bob Blaesing, IDEM  
Gary Development Company  
#2 -- Runoff from GDC entering  
Grand Calumet River via gully  
formed by erosion. Note River  
discoloration (brown) due to clay  
being carried in runoff.

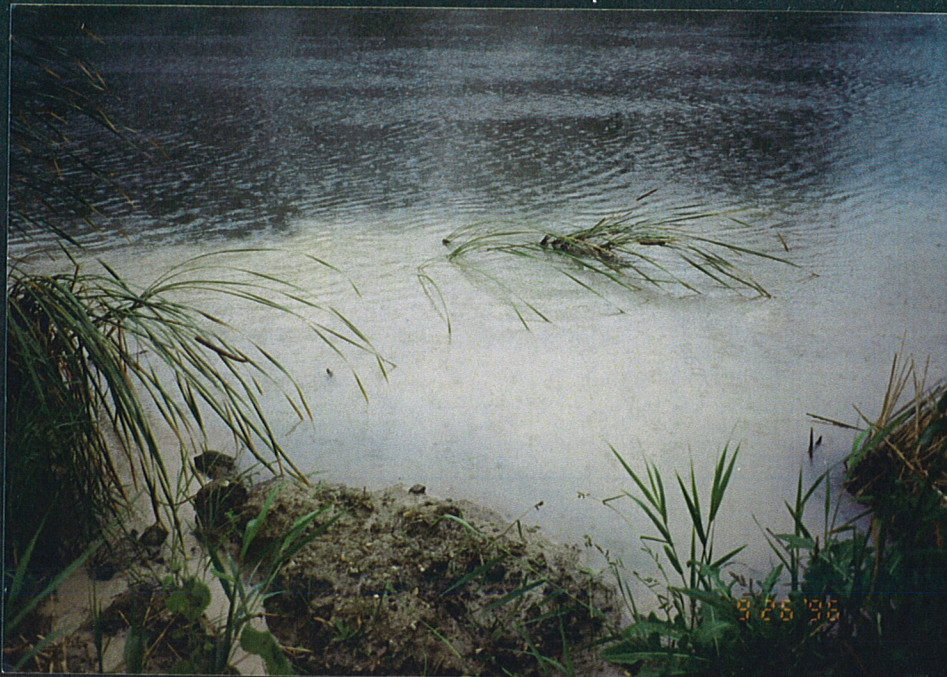
9-26-96 Bob Blaesing, IDEM  
Gary Development Company  
#3 -- More detailed view of gully  
seen in photo #2, showing point  
source nature of runoff from GDO

Note brown discoloration of  
Grand Calumet River.

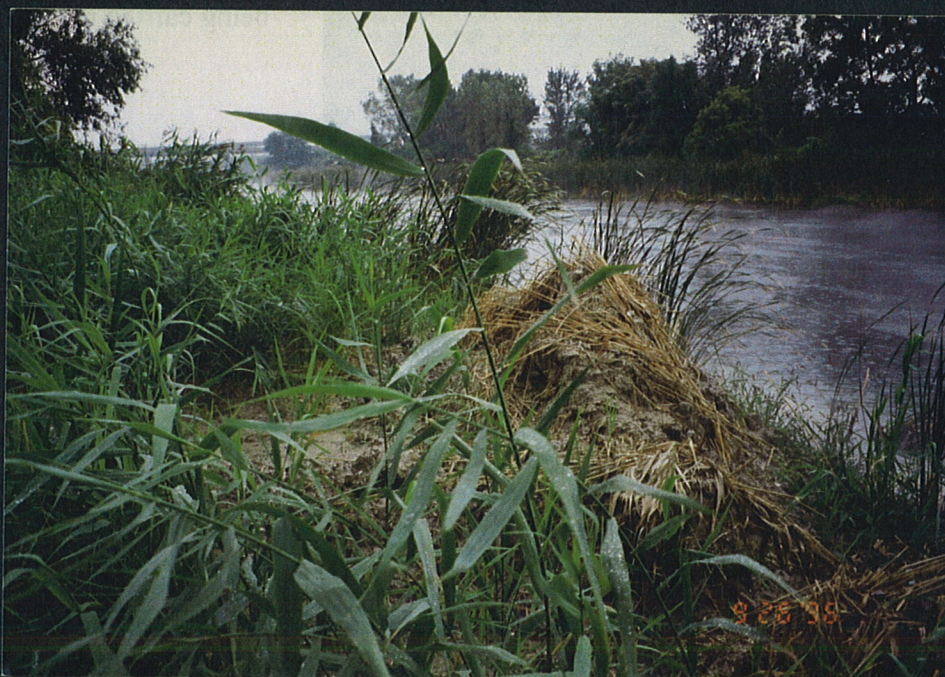
9-26-96 Bob Blaesing, IDEM  
Gary Development Company  
#4 -- View of pile of clay/dirt  
dumped in wetlands area adjacent  
to Grand Calumet River.

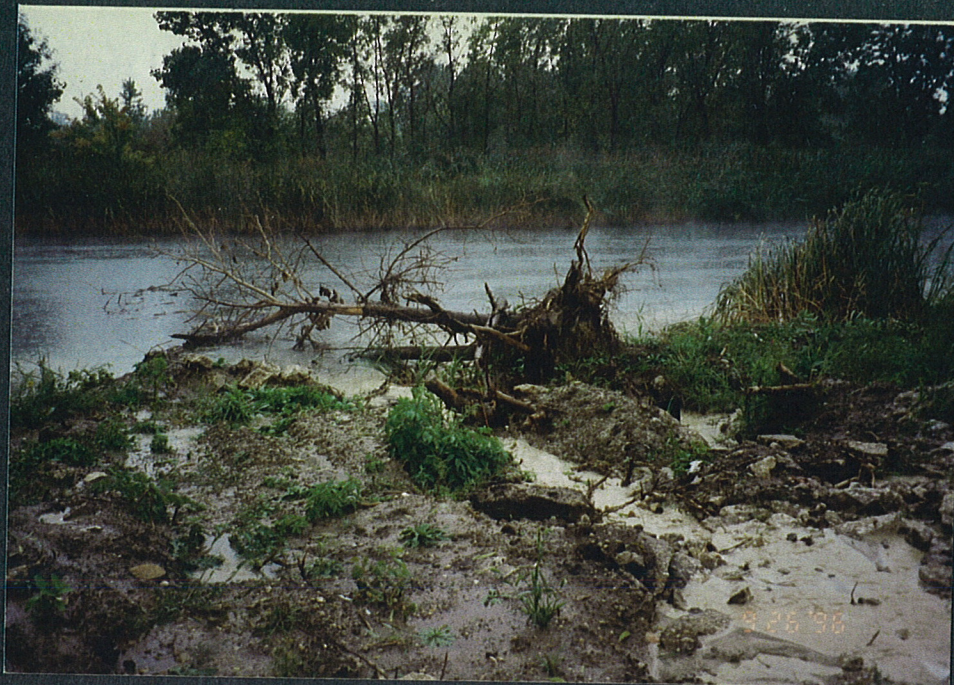
9-26-96 Bob Blaesing, IDEM  
Gary Development Company  
#5 -- View of point source and

sheet erosion from GDC property  
to Grand Calumet River. Note  
heavy clay load in runoff, and  
brown discoloration of River.

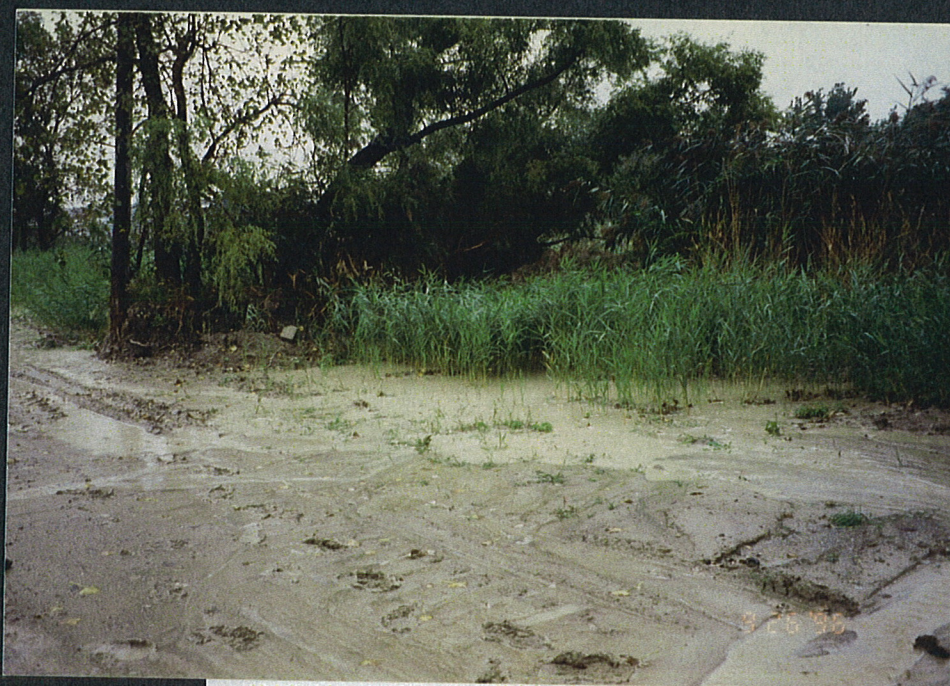
9-26-96 Bob Blaesing, IDEM  
Gary Development Company  
#6 -- View of erosion of clay cap  
from GDC landfill and road  
material into wetland area adjacent  
to the Grand Calumet River.

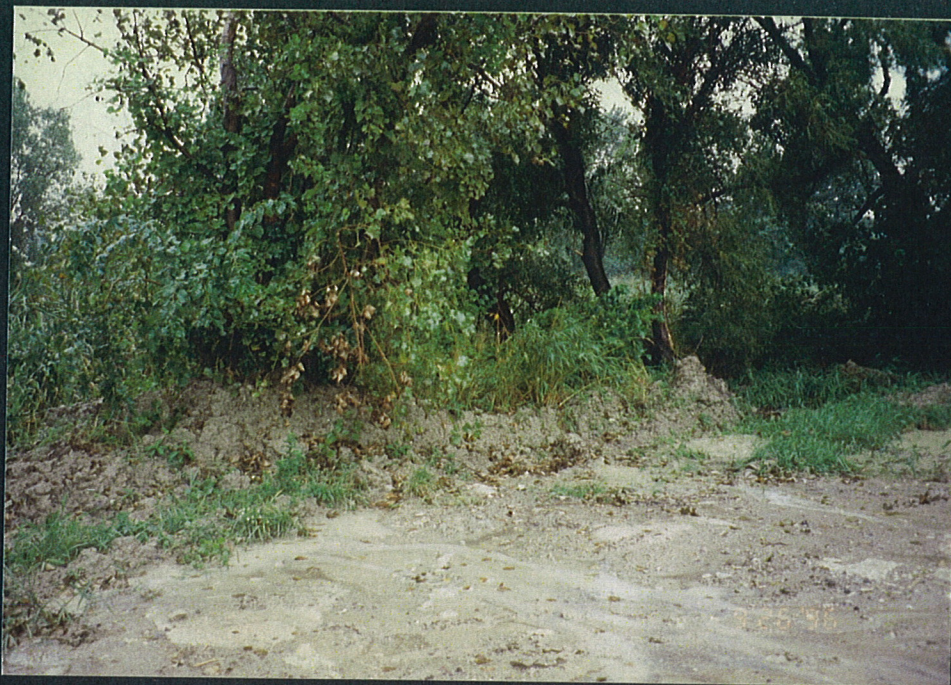
9-26-96 Bob Blaesing, IDEM  
Gary Development Company  
#7 -- View of cap and road  
material which has been graded

into wooded wetland at GDC,  
adjacent to the Grand Calumet  
River at the GDC site.

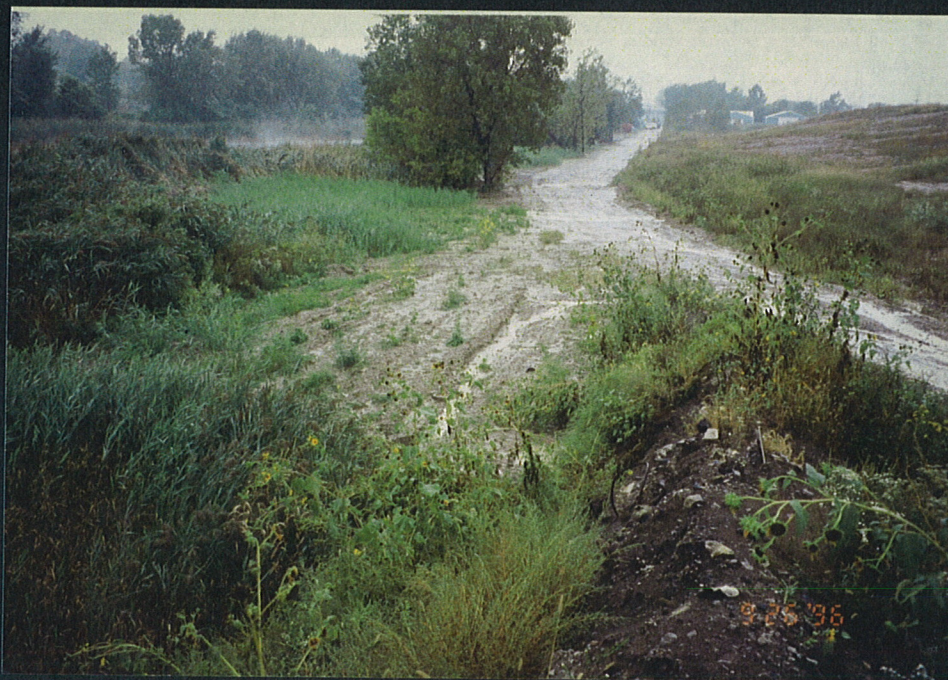
9-26-96 Bob Blaesing, IDEM  
Gary Development Company  
#8 -- View of road at GDC at toe  
of landfill, which runs along Grand

Calumet River, as seen from point  
at which road rises. GDC offices  
in background. Note runoff and  
rill erosion on slope into wetland  
area.

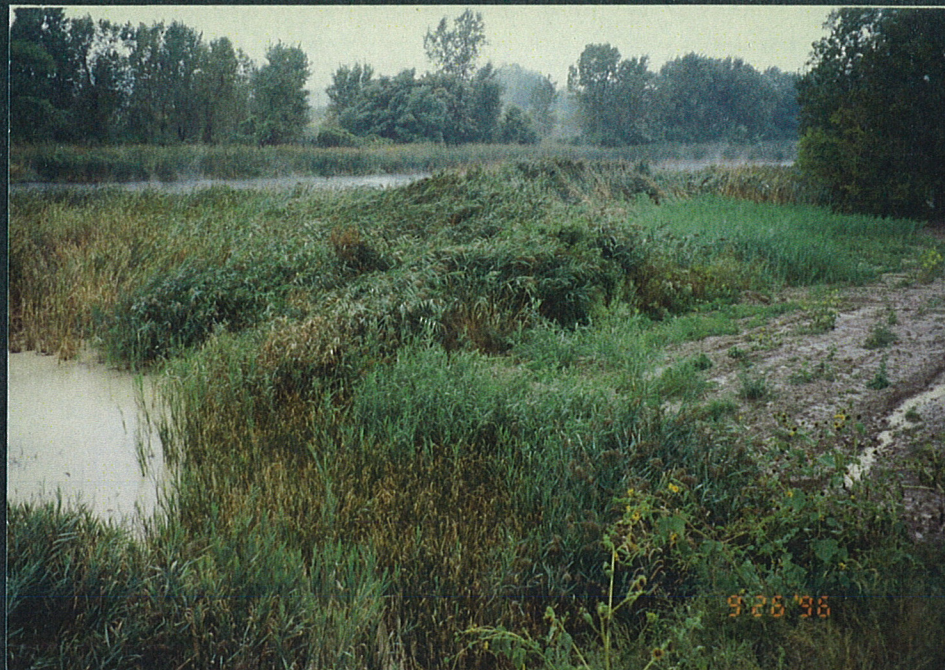
9-26-96 Bob Blaesing, IDEM  
Gary Development Company  
#9 -- Continuation of photo #8,  
showing ponded wetland area in

SE corner of GDC property. Not  
brown color of pond, and Grand  
Calumet River in background.

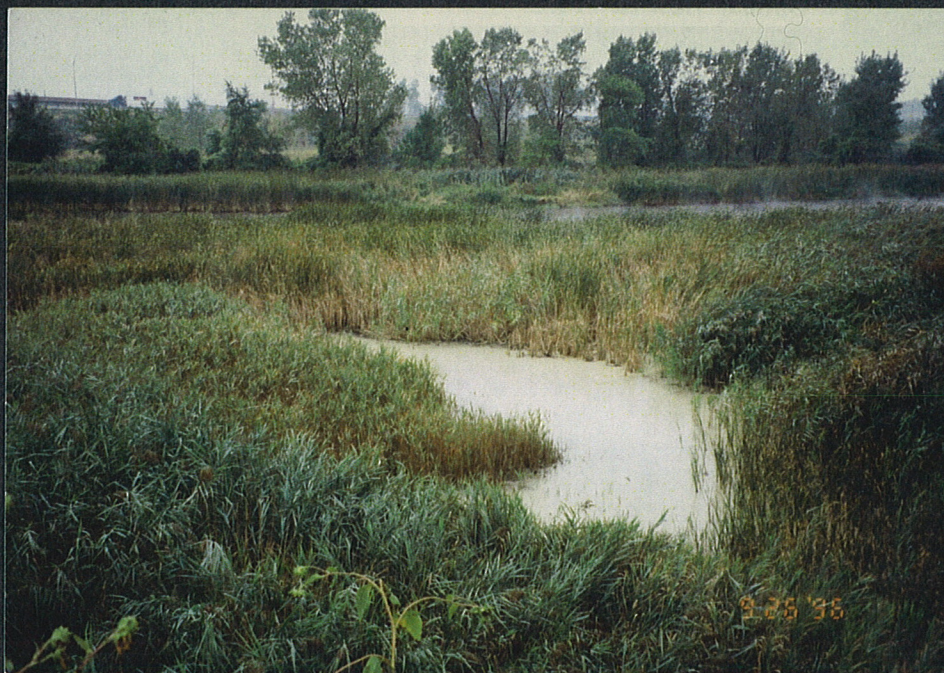
9-26-96 Bob Blaesing, IDEM  
Gary Development Company  
#10 -- View of ponded wetland  
area at SE corner of GDC site.  
Note brown color of ponded  
water. Grand Calumet River in  
background.

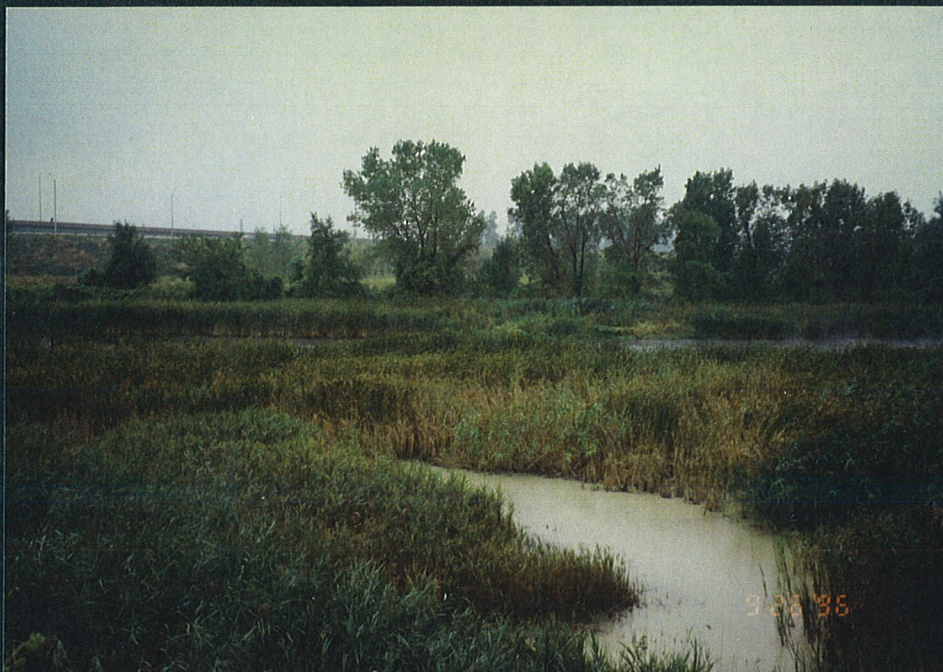
9-26-96 Bob Blaesing, IDEM  
Gary Development Company  
#11 -- View of ponded wetland  
area at SE corner of GDC site.  
Similar view to #10.
